Propulsion Train - stern tube, plumber block, universal couplings					REF:	Roger-07

To inspect, adjust and lubricate the propulsion train from but not including the reduction gearbox to and including the stern tube.

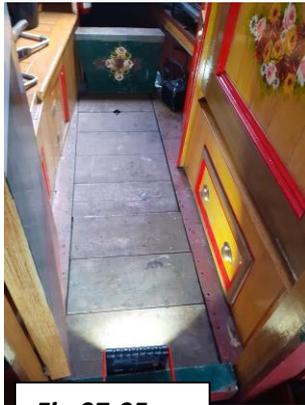
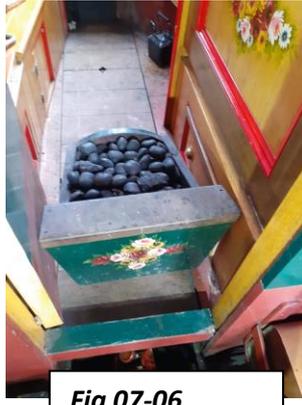
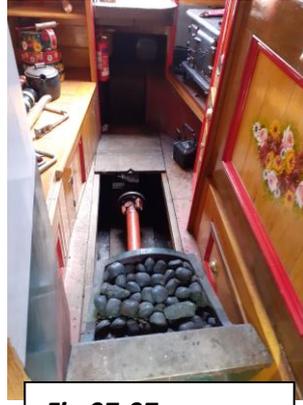
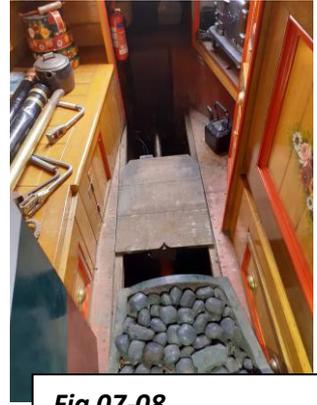
Fig 07-05
Undisturbed
Cabin floor

Fig 07-06
Coal box pulled
forward

Fig 07-07
First floor panel
removed

Fig 07-08
Second floor panel
pulled forward ready
to be lifted

The photos above, taken from the engine room door, show the easiest way to gain access to the propeller shaft, aft universal joint, plumber block and stern tube.

- Pull the coal box to the front of the cabin.
- Remove the first section of flooring and store safely out of the way.
- Pull the second flooring panel forward so it clears the lockers and lift out. Store safely out of the way.

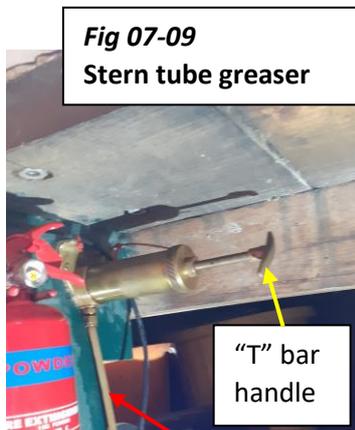
Fig 07-09
Stern tube greaser

The stern tube is greased by turning the “T” bar clockwise on the end of the greasing cylinder, which is located under the cabin step, see **Fig 07-09**. It should be turned **by hand** until resistance is felt – probably no more than one full turn. Refill the cylinder as described in **Appendix 2**.

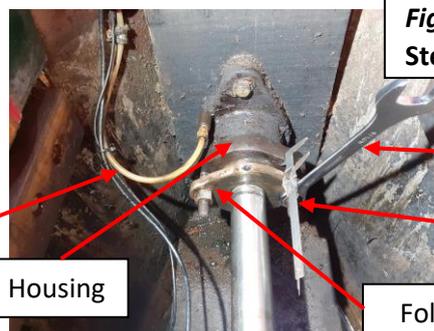
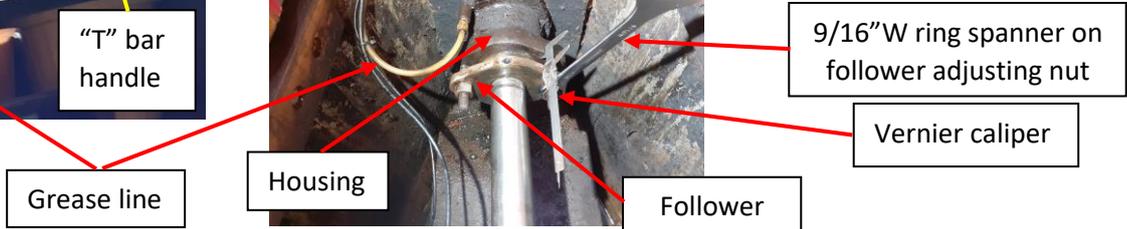
Fig 07-10
Stern tube follower assembly

The stern tube follower adjusts the stuffing gland and using the 9/16”W ring spanner, nip up the nuts equally until resistance is felt – **do not be tempted to overtighten otherwise the shaft might seize in the stuffing gland**. Using a vernier caliper or steel rule, check that the gap between the follower and the housing is equal on both sides, see **Fig 07-10**. Turn the propeller shaft by hand to confirm that the gland is not too tight. Do not attempt to adjust the coach bolts through the stern tube housing into the stern post.

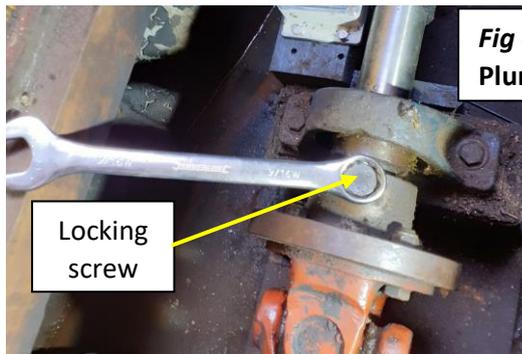
Fig 07-11
Plummer block

The shaft through the plummer block is pinched to the aft universal coupling by a large locking screw with a 9/16" W head. This can work loose and should be tightened with the ring spanner.

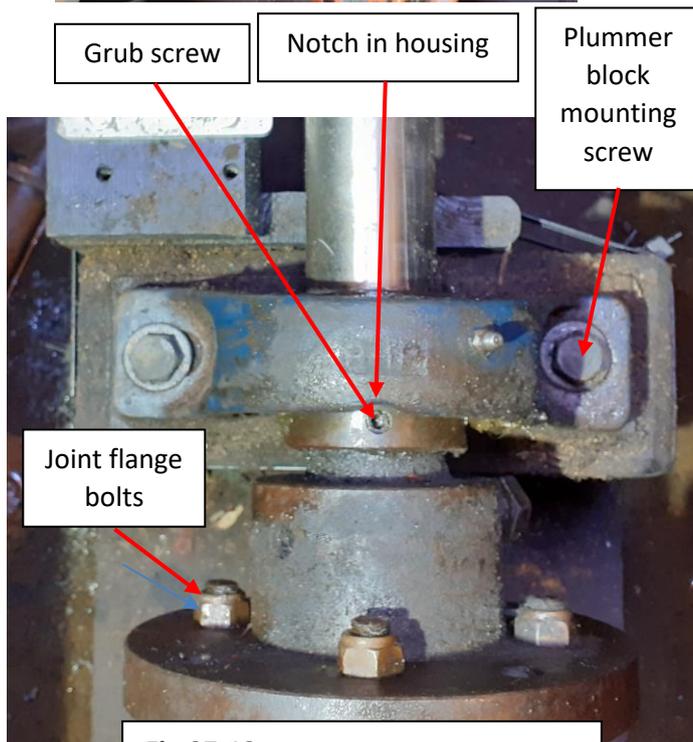
Fig 07-12
Plummer block grub screws

The plummer block inner race is secured to the prop shaft with two socket head grub screws set at 90deg to each other and they can work loose. To check, turn the prop shaft by hand to line up one grub screw with the notch in the plummer block housing and clean out the socket so that the 3/16" Allen key can be used, see **Fig 07-12**. Tighten the first screw and turn the shaft again to line up the second screw and repeat. Using the grease gun, pump grease into the bearing housing until clean grease appears. Wipe away any excess grease. Check the tightness of the flange bolts and the plummer block mounting bolts with the 19mm ring spanner.

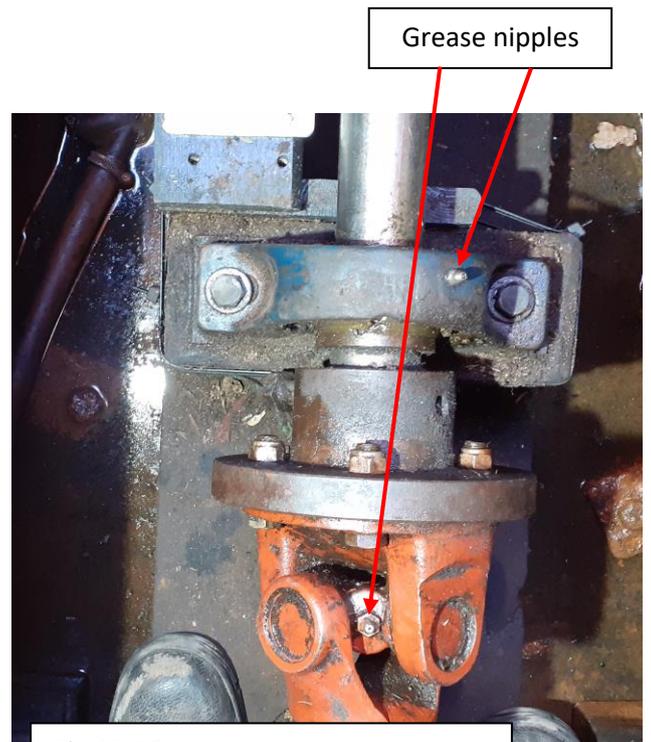
Fig 07-13
Plummer block and aft universal joint grease nipples

There is one grease nipple on the universal joint. Turn the prop shaft by hand until it is visible and use the grease gun to pump in grease until clean grease appears. As before, wipe away any excess grease.

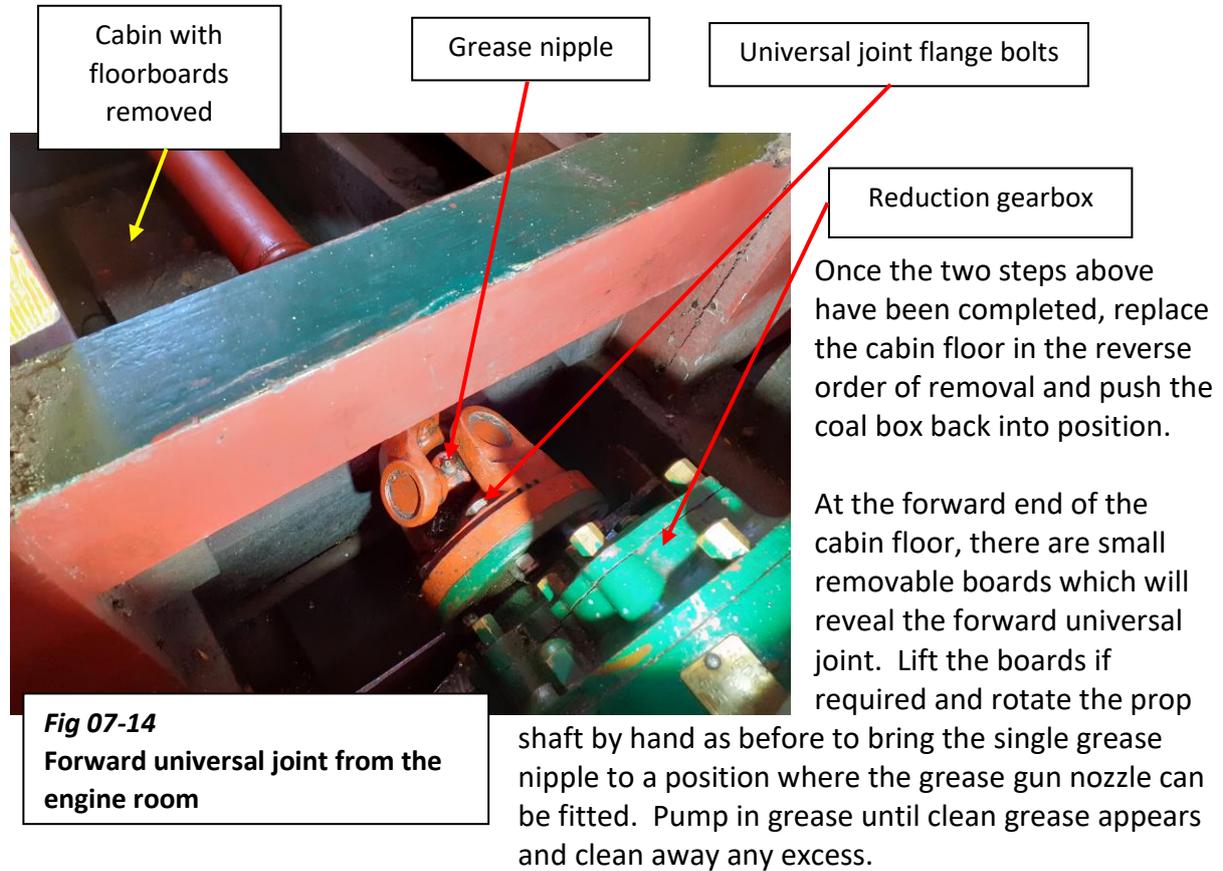
The forward universal joint is visible from the engine room but it may be easier to grease it from the cabin.

It's difficult to fit a ring spanner onto the flange bolts. Rock the shaft back and forth by hand and make a visual check. If they appear to be loose, inform the **Conservation Manager**.

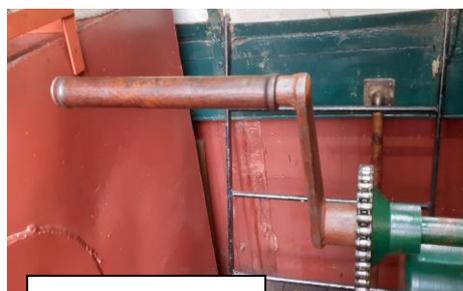
There is a remote chance that someone might start the engine when the transmission train is being serviced. **This is potentially very dangerous and the engine needs to be isolated.** The simplest way of doing this is for the person carrying out the task to keep the starting handle - see **Fig 07-15**, shown in the starting position - with them until all work is finished.

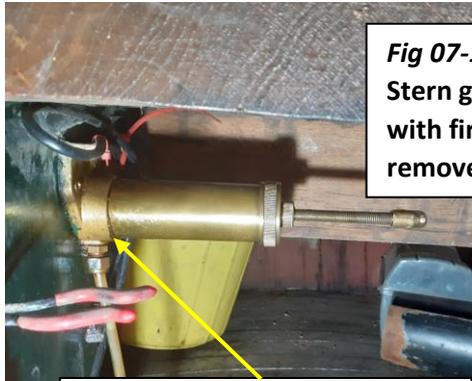
Fig 07-16
Stern gland greaser
with fire extinguisher
removed

Unscrew the greaser body from the base mount, see **Fig 07-16**. Grease will be flush with the end of the cylinder, see **Fig 07-17**.

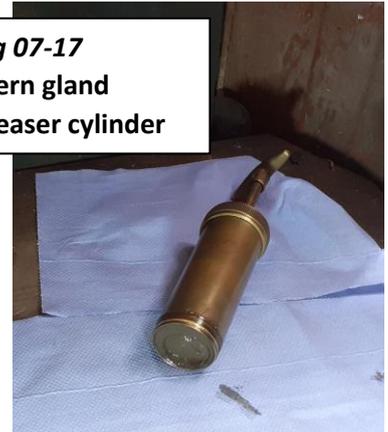
Fig 07-17
Stern gland
greaser cylinder

Using the "T" handle unscrew the greaser piston until the grease is pulled away from the end of the cylinder.

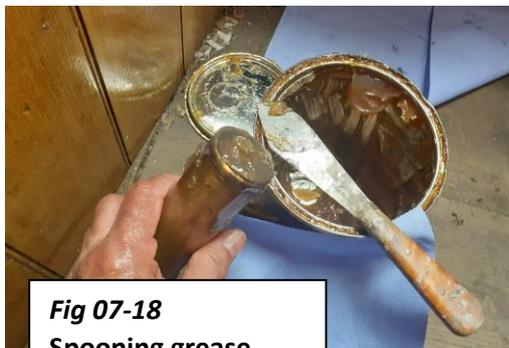
Fig 07-18
Spooning grease
into the stern gland
greaser

Using a clean pallet knife or similar, spoon **Morris K99** water resistant grease into the cylinder, see

Fig 07-18 until the grease is flush with the cylinder end. Repeat until the piston is fully retracted and the grease up to the end of the cylinder. Screw the cylinder back onto its base.
